Final Inspection

Julkowski Inc

5983 Voyageurs Trail, Biwabik, MN 55708

Inspection Date: Thu Jul 20 2023

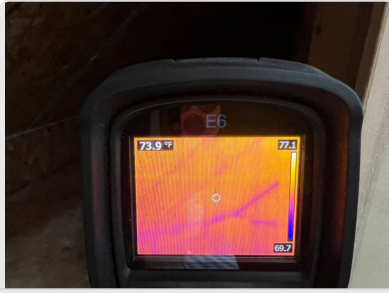
SIPs roof in bedrooms and behind kneewalls appear well sealed

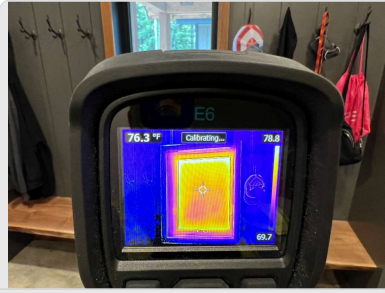
No air infiltration around window trim

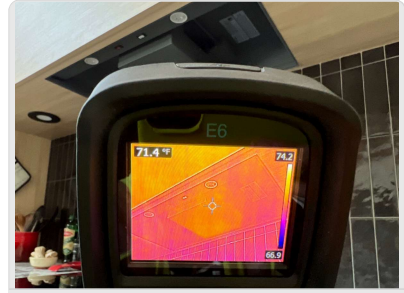
No air infiltration around range hood

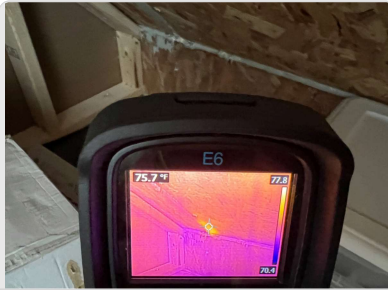
Minor air infiltration around seam between SIPs roof and wall in attic/knee wall space over garage

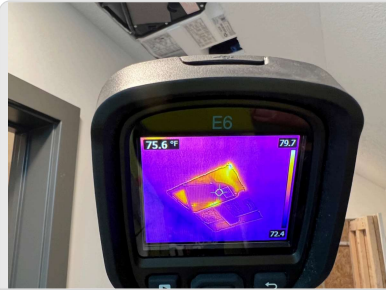
Air infiltration around ERV fresh air intake ducts

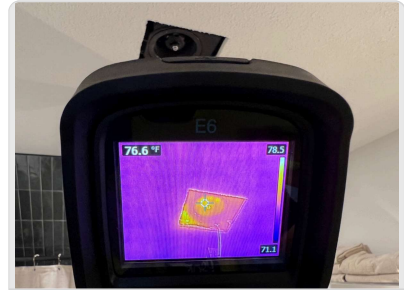
Air infiltration around bath exhaust fan ductwork

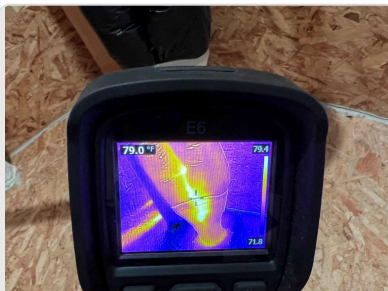
Air infiltration around ERV intake/exhaust penetrations to outside

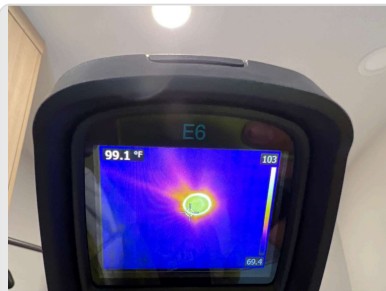
Air infiltration around flush-mount LED light fixtures above laundry room (note conditioned space above—possible air infiltration into/through framed floor assembly)

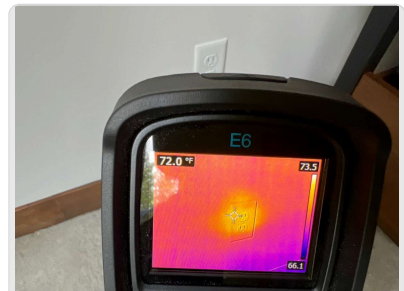
Minor air infiltration around exterior wall electrical boxes

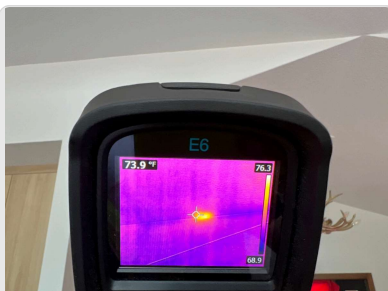
Possible air infiltration (or missing insulation) at soffit above front entry door. Note soffit is within conditioned space.

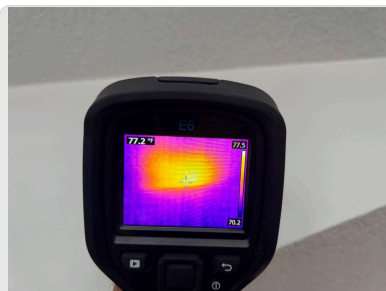
Possible air infiltration (or missing insulation) at soffit above front entry door. Note soffit is within conditioned space.

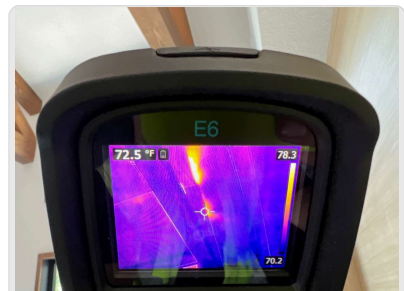
Air infiltration around vaulted ceiling beam above kitchen

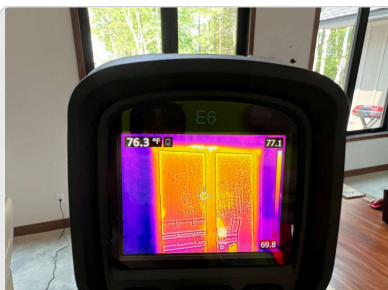
Minor air infiltration around back patio door top seal

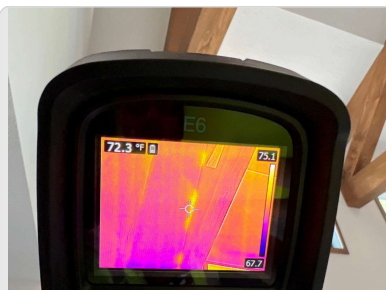
Air infiltration around vaulted ceiling beam above fireplace/living room

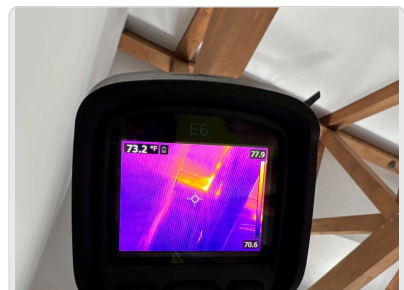
Air infiltration around vaulted ceiling beam above fireplace/living room

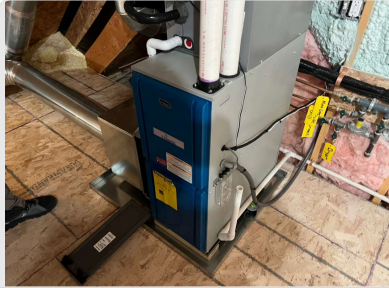
Heat Pump/Furnace is primary for cooling, secondary for heating. Primary heat source is in-floor hydronic (see boiler photos below).

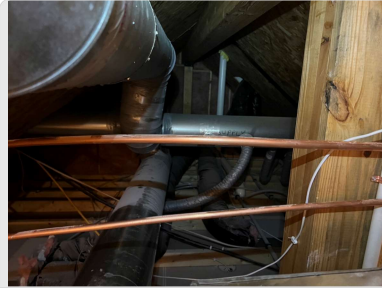
SIPs framed house (including roof system), all ductwork within conditioned space. Did not perform duct Leakage to Outside testing. Note living room supply and return registers located ~12-14ft up, unable to access and seal off for testing.

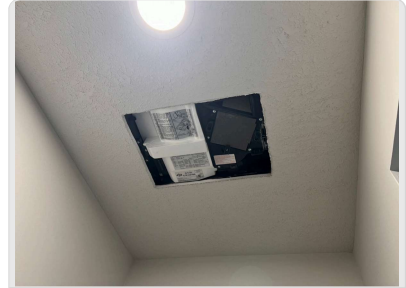
3x cartridge/ductless ERVs in house

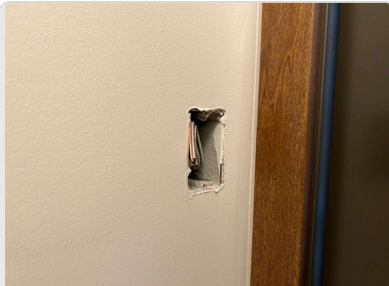
ERV wiring incomplete, unable to power on or test

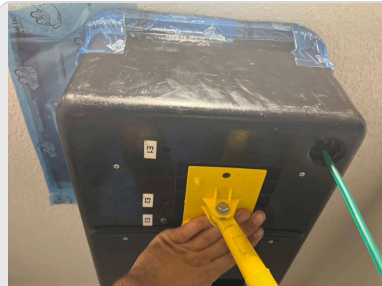
Experimental testing of air infiltration through ERVs. Approx 12-13 CFM each, likely being pulled through fresh-air/intake ductwork (not dampered)

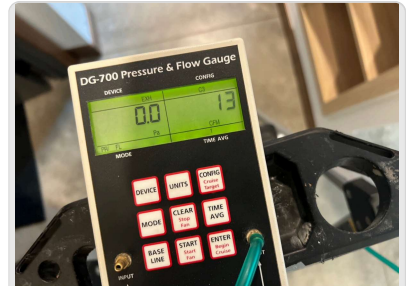
Experimental testing of air infiltration through ERVs. Approx 12-13 CFM each, likely being pulled through fresh-air/intake ductwork (not dampered)
