Online Damage Report

**The 25 September 2015 Johns Island Tornado**

University of Florida's Wind Hazard Damage Assessment Team

28 September 2015

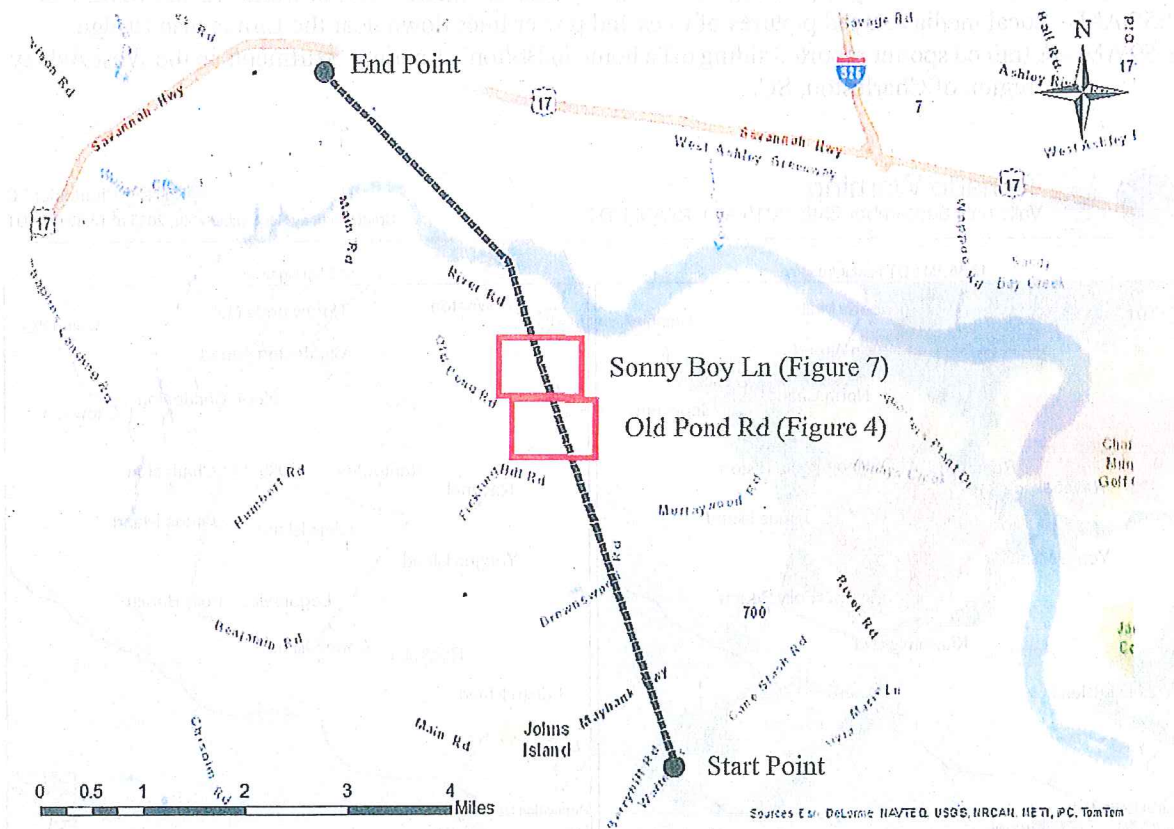
Figure 3: Overview of approximate damage path (dashed black line) through Johns Island, SC with areas of major damage shown in red outlines.

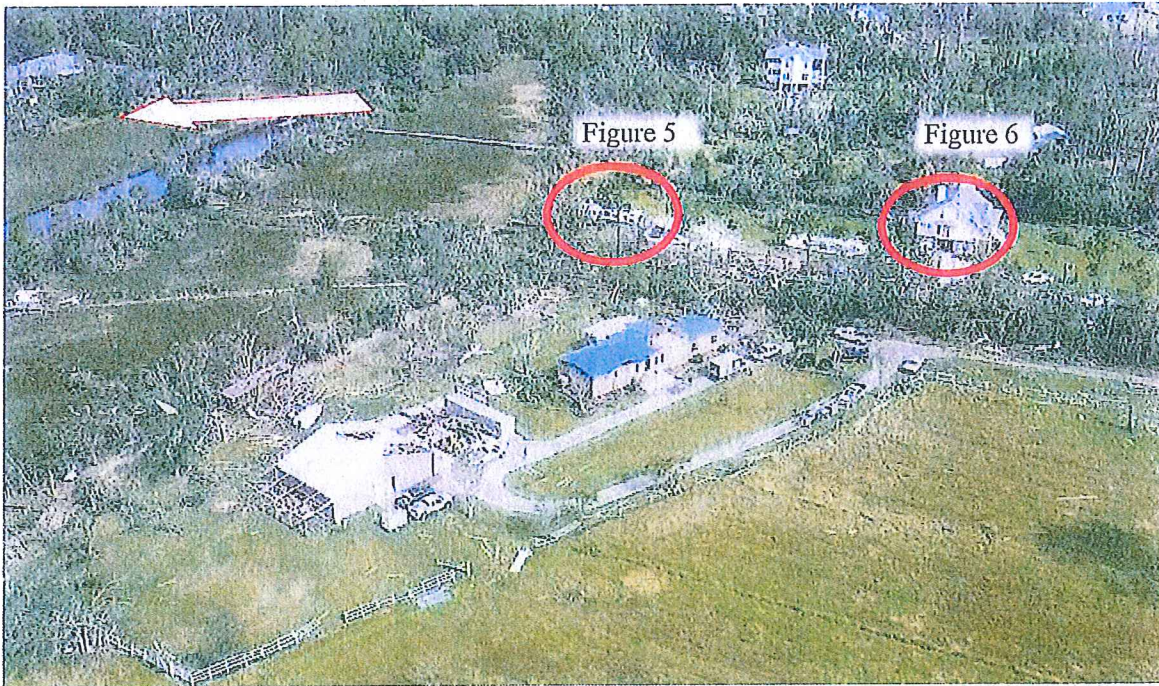
Figure 4: Aerial view of damage along Old Pond Rd. Roof damage was observed to two commercial buildings and a nearby home suffered damage to a bay window, garage door and roof covering. A camper was flipped in the same property. Approximate direction of tornado is indicated by white arrow. (Photo from [ABCNews4.com](http://ABCNews4.com))

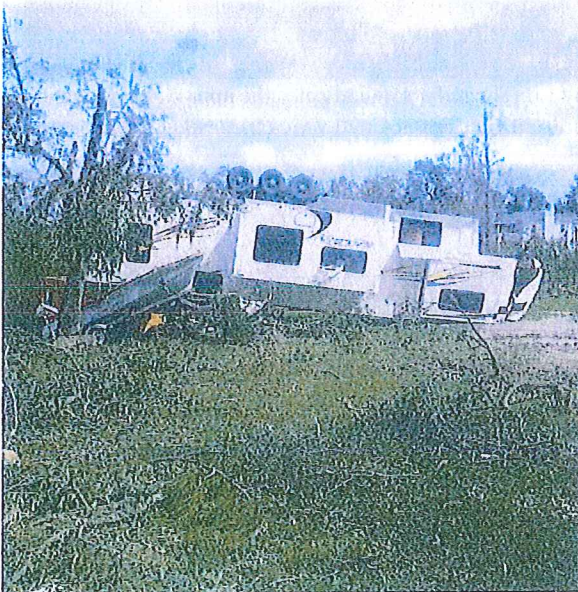
Figure 5: Toppled camper on property along Old Pond Rd (Photo Courtesy of [Karla Mata](#)).

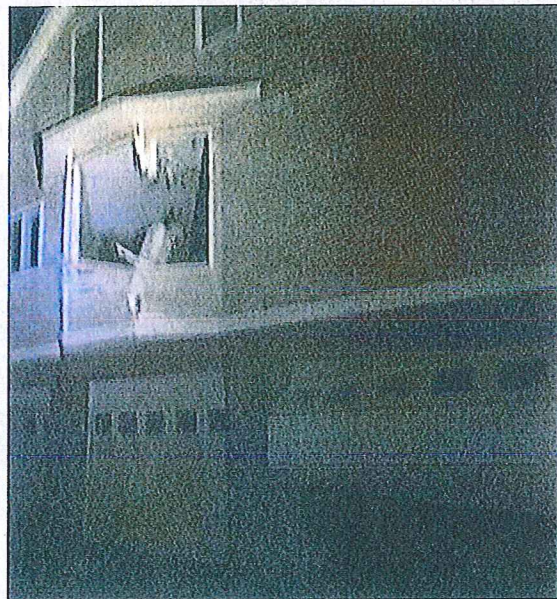
Figure 6: Bay window breached and garage door blown out in home along Old Pond Rd. Photo courtesy of [Stephanie Maxwell, WSOC Channel 9](#))

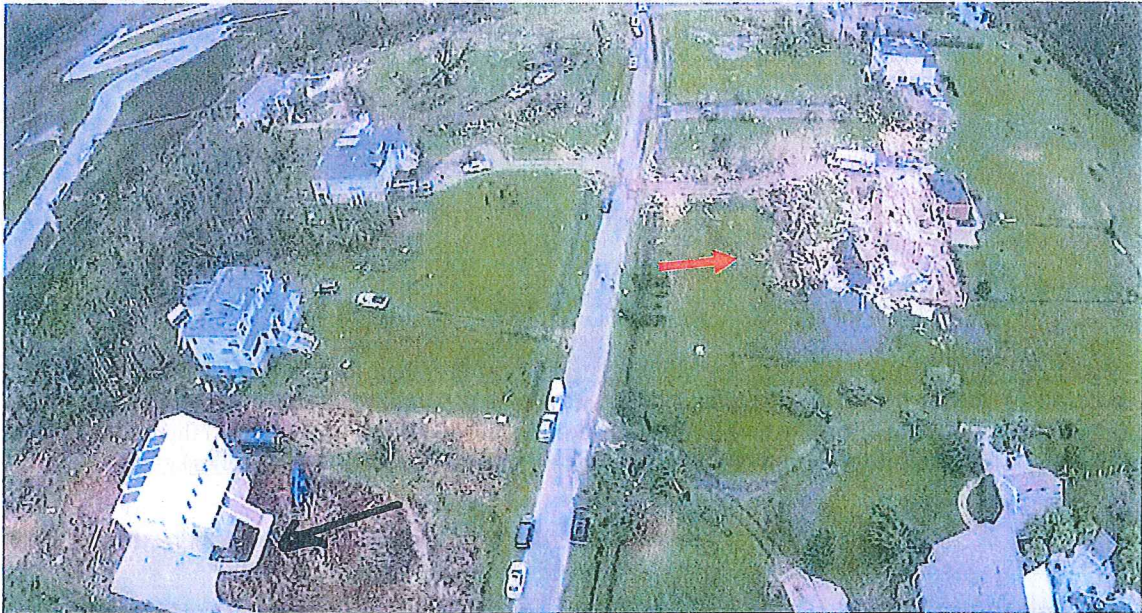
The worst damage caused by this tornado occurred along Sonny Boy Lane where a one-story home was completely destroyed (Figure 8). The roof and attic structure were ripped away and the debris deposited throughout the neighborhood. The aerial view shows several downed trees around nearby homes, but no other major damage on them. Roof covering loss is observable in several homes and there were also many reports of broken windows in these homes. The extent of the damage to the destroyed home is apparent from a ground view photograph, showing the front elevation with the partially removed roof structure resting on the ground (Figure 8.) Our report draws sharp focus on this home to answer questions regarding the size of the tornado, strength of construction and effectiveness of building codes.

Figure 7: Aerial view of damage to homes along Sonny Boy Ln. The red arrow indicates the approximate location and direction of the photo shown in Figure 8. Photo taken from [Charleston County Government aerial survey](#).

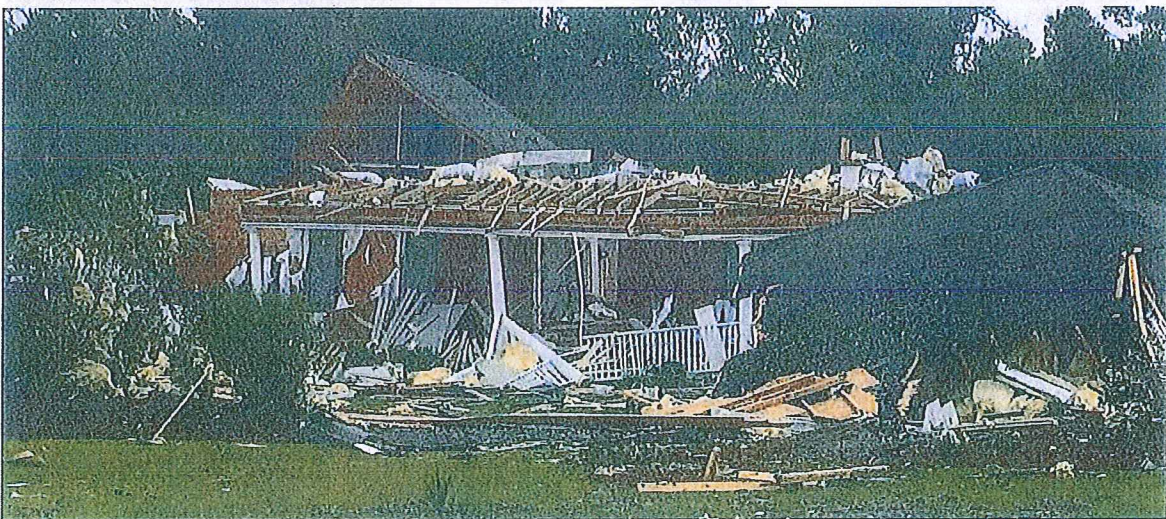
Figure 8: Ground view of destroyed home along Sonny Boy Ln. Photo courtesy of [Bryan Luhn, WCBD Channel](#)

The destroyed home shown in Figure 7 and Figure 8 was located at 727 Sonny Boy Ln. While the other houses suffered EF0 or EF1 damage, this structure exhibited quite severe damage (DOD 6 - large portions of roof structure removed), making it an EF2 level damage. By this context, estimated wind speed would be between 111 and 135 mph.

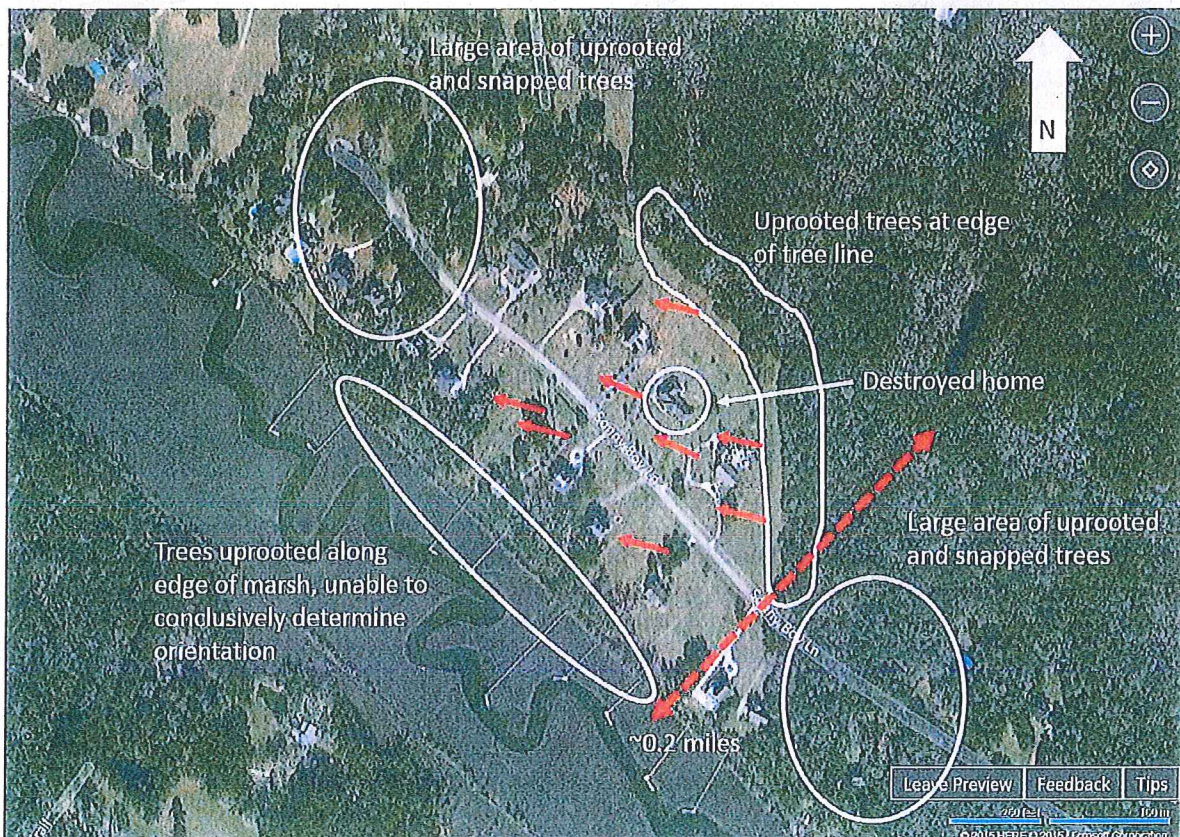
The level of damage this home sustained is starkly greater than that occurring on the surrounding homes – making one consider whether the tornado vortex was shortlived on the ground or that it skipped over other homes. No other homes along the road had any significant structural damage, there were only reports of roof cover loss and a few cases of windows or doors failing ([Post and Courier](#)). An overview of the damaged area given in Figure 9 shows large areas of tree damage both to the east and to the west of the destroyed home, with relatively consistent tree-fall orientations along both sides of Sonny Boy Ln. If a tornado had passed down Sonny Boy Ln, we would have expected to see fallen trees pointing in opposite directions on opposite sides of the tornado path. An [aerial video](#) of the damage shows that this was not the case and indeed, looking at the overall patterns and locations of damage, it appears implausible that any sized vortex could have passed directly over the destroyed home without encountering at least some of the other homes. This leads us to consider other explanations.

Figure 9: Overview of Sonny Boy Ln showing major areas of fallen or snapped trees and general tree-fall orientations (red arrows) along Sonny Boy Ln.

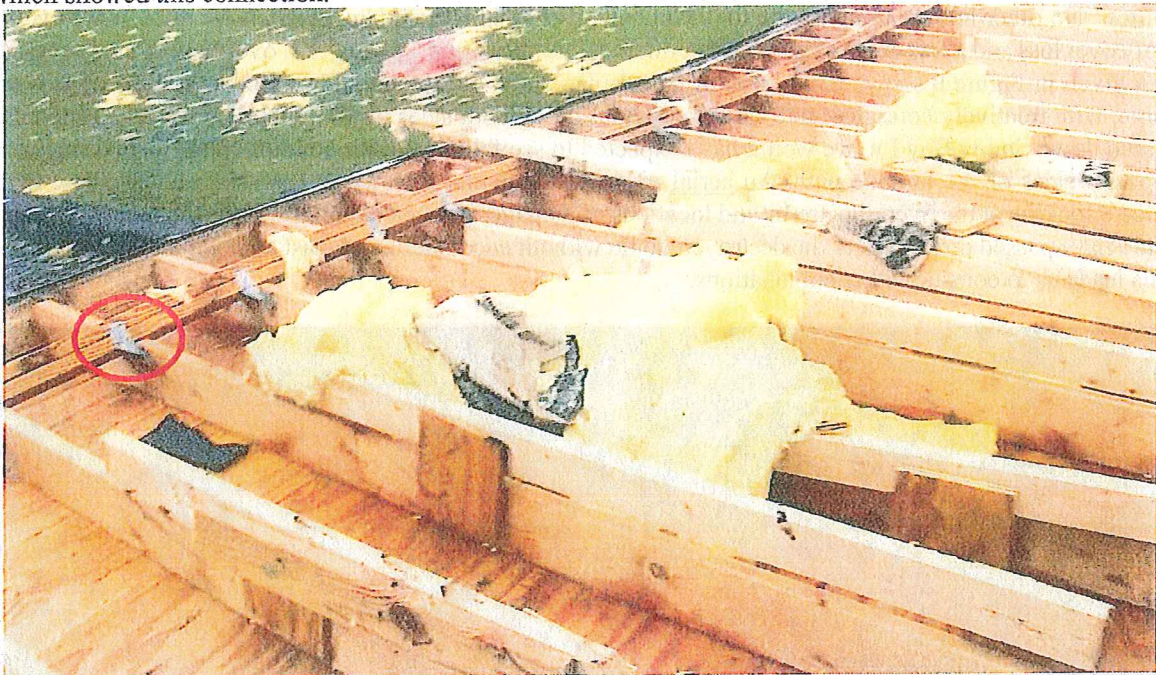
The destroyed home was built in 1999, and we learned from [ABCNews4.com](http://ABCNews4.com) that it was designed by the homeowner. The house was a wood-frame structure, having plywood sheathed exterior walls, plywood roof sheathing and a brick façade. The hip roof structure was constructed with long-span rafters and had an approximate 8:12 roof slope (36°) based upon the damage photos. Hurricane straps connected the rafters to the horizontal double wall plate as shown in Figure 10. The top plates remained attached to the rafters as the roof failed, cleanly separating from the wall structure beneath. The roof ridge (rafter-to-rafter) connection at the peak appears to be toe-nailed – no metal straps were observable in the available photos which showed this connection.

Figure 10: Hurricane straps present between rafters and wall top plate. However, the wall top plate separated cleanly from the wall structure and failed along with the roof, indicating the load path between the wall plate and vertical studs may have been the critical failure point resulting in the observed damage to this home (Photo courtesy of [ABCNews4.com](http://ABCNews4.com)).

We concluded there was nothing unusual in shape and orientation of the house, topographic or exposure effects, or special meteorological phenomena to account for the mode of failure, and we are left to suspect there may be a structural deficiency in the vertical load path. The evidence for this is visible in the “clean” separation of the wall double-top plate from the vertical studs Figure 10. That is, neither the rafter nor the studs themselves were fractured, the connection merely separated. The common construction of the stud walls is to nail it into the end of the vertical studs – nails are installed into the end grain of the wood members and the withdrawal capacity of this connection is very low. Thus, while the metal hurricane straps provide a robust connection of the rafters to the top plate (using a nail group of 3-4 nails, loaded in shear), if the vertical studs are not directly engaged by the metal tie, the weak connection between horizontal wall plate to vertical stud remain in the load path and lead to this failure. Common design practices for addressing this connection can be found [here](#). A far stronger connection for attaching the horizontal top plates to the vertical wall studs is by using through metal straps and/or through overlapping the wall sheathing on to the top plates such that the sheathing and its fasteners form the connection.

- The top rafters were connected to the top plate with hurricane straps but there is no evidence of positive attachment of the horizontal top plate to the vertical wall studs, either through metal straps or overlapping of the exterior sheathing.
- Rafters meeting at the peak of the roof were toe-nailed together rather than connected with metal plates or straps.

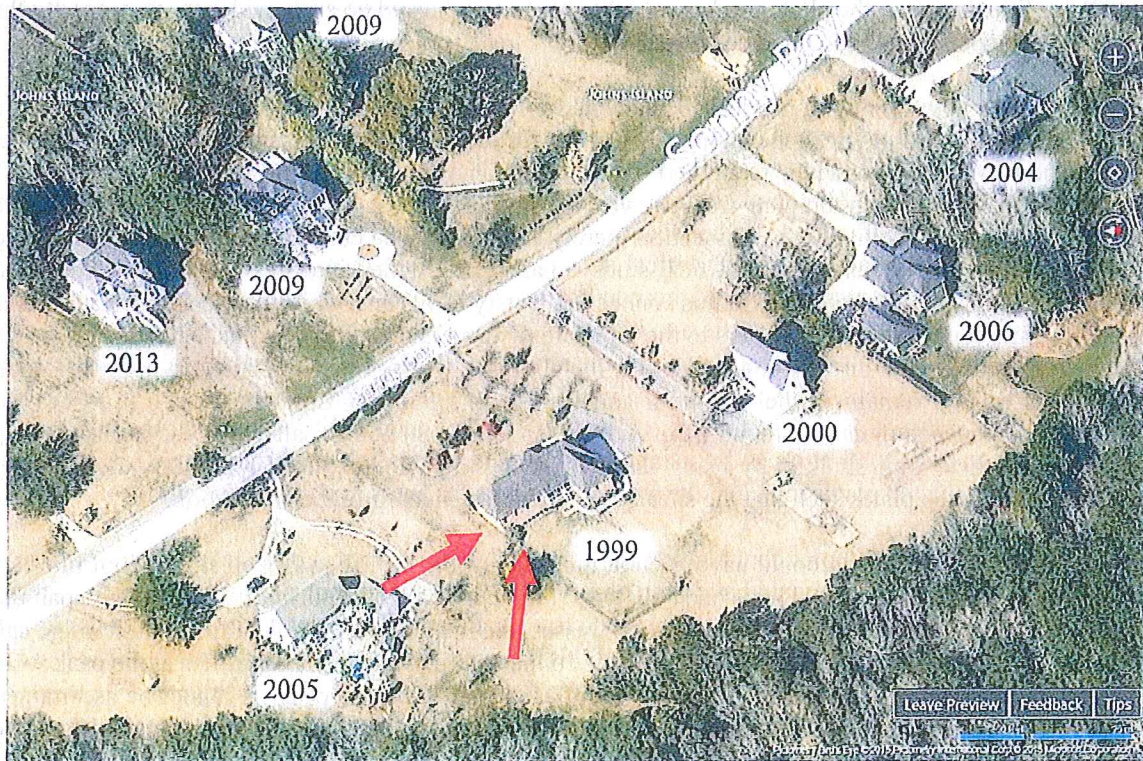
Regardless of the exact cause of failure in this home, the lack of damage to surrounding homes is still surprising. The [Charleston County tax assessor database](#) indicates that the destroyed home was built in 1999. The year built of surrounding homes are shown in Figure 11. The destroyed home was the oldest home on the street, and one of two (out of 8) that were built prior to South Carolina’s adoption of the International Building Code in 2001. The second-oldest home, located immediately north-west of the destroyed home, was built in 2000 and had a roof span approximately half that of the destroyed home. Assuming these homes had similar construction, the shorter roof span would result in much lower wind uplift loads (suction) on the roof structure. This alone could explain the difference in structural performances of these two homes.

Figure 11: Birds eye view of the destroyed home. Solid red arrows indicate the range of wind directions the home was exposed to during the passage of the tornado based on the debris and treefall patterns (see Figure 7). The white arrow with red outline indicates the approximate direction of travel of the tornado as it passed this area. The exact path of the tornado center is not known however.
