Air Leakage Diagnostics

22392 Getaway Circle, Deerwood, MN 56444

Summary: The Element Group/Midwest Aerobarrier's findings from the Air Leakage diagnostic assessment that was performed on the Cayuna cabin on Thursday 1/28/21.

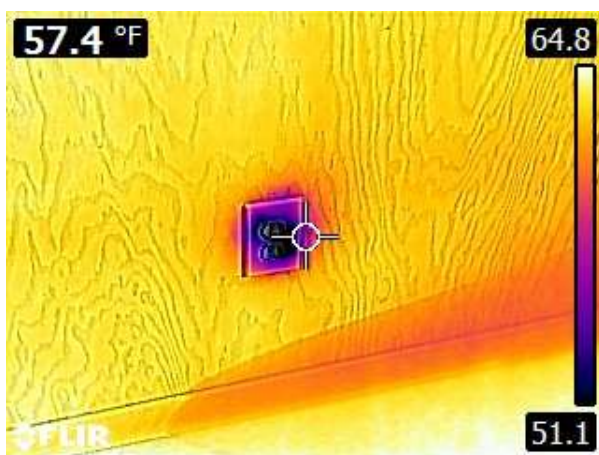
**Electrical box:
Main Room**

Electric box covers: Air leakage was detected in multiple electrical outlet boxes throughout the building. Much of this was detectable with the IR scan.

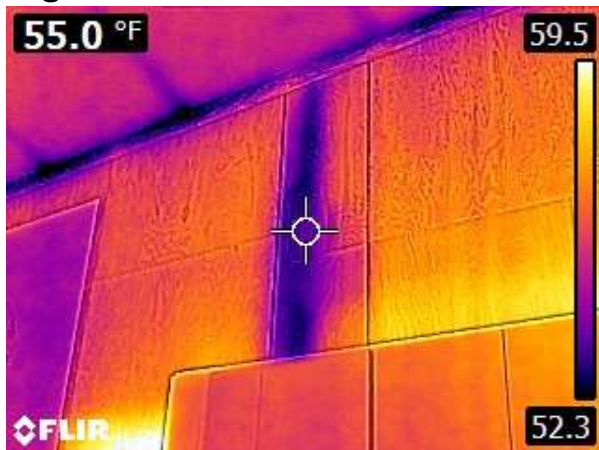
**SIP Panels:
High Wall of Kitchen**

SIP Panel seams: Several joints in the SIP panel showed both a lack of sufficient insulation as well as air leakage.

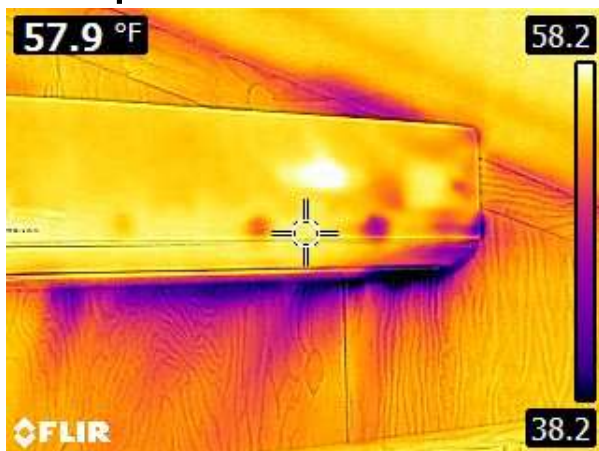
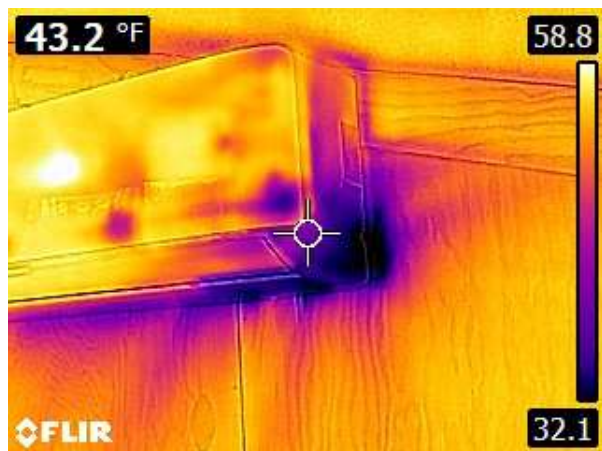
Mini-Split:

Mini-Split Ducting: The seal between the Mini-Split in the loft and the exterior wall was incomplete and indicated a significant amount of air leakage.

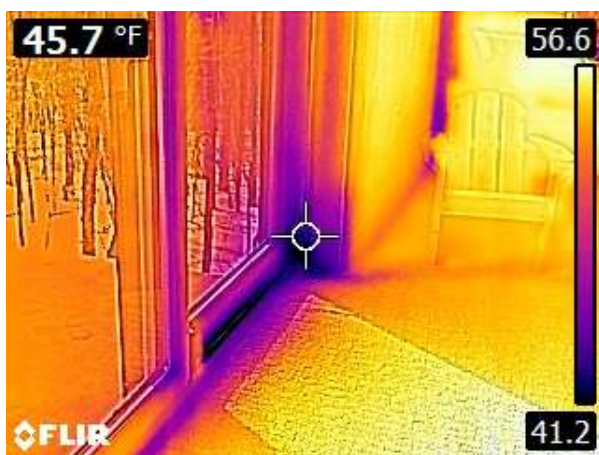
**Sliding Doors:
Loft Area**

Sliding Doors: Sliding doors were not clasping consistently and effectively due to ice in the track system.
